Submission for the  
NEW ZEALAND CONCRETE SOCIETY  
**CONCRETE AWARDS 2007**

**WAIANAKARUA NORTH BRIDGE**

Submitted by: Dave Charters  
OPUS INTERNATIONAL CONSULTANTS

### **S.H.1 WAIANAKARUA NORTH BRIDGE WIDENING**

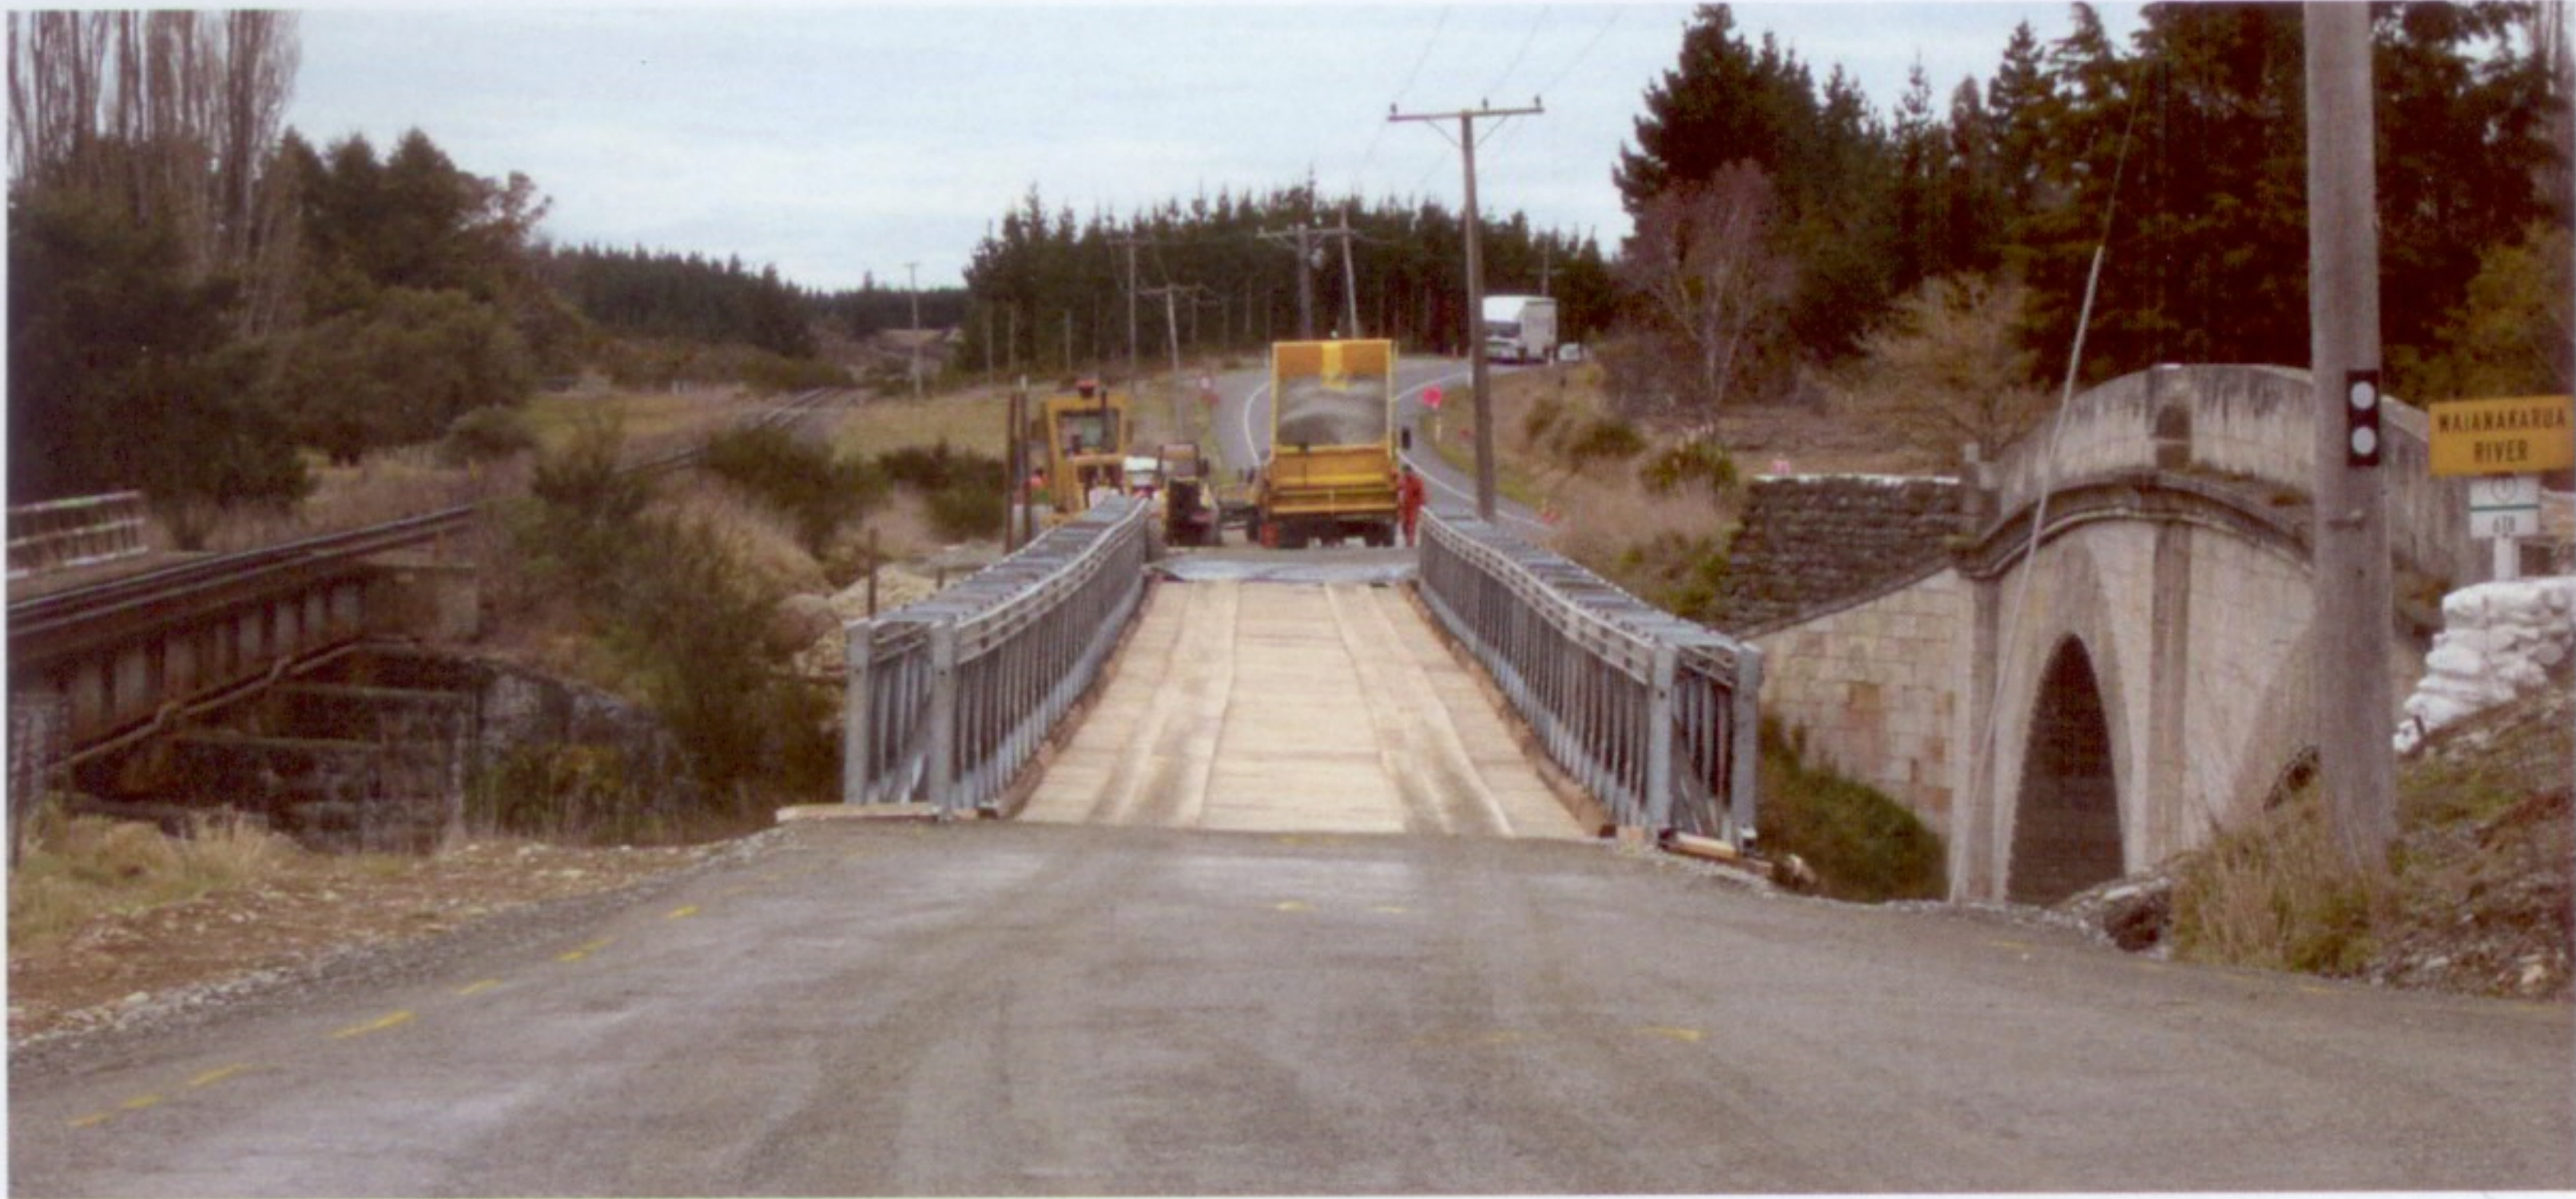
Figure 1. A Bailey Bridge with temporary approaches was constructed adjacent to the Waianakarua River Bridge

- The narrow road corridor did not permit the use of the bridge during the works; necessitating a Bailey Bridge. (Ref. Figure 1) to carry traffic during the construction phase.

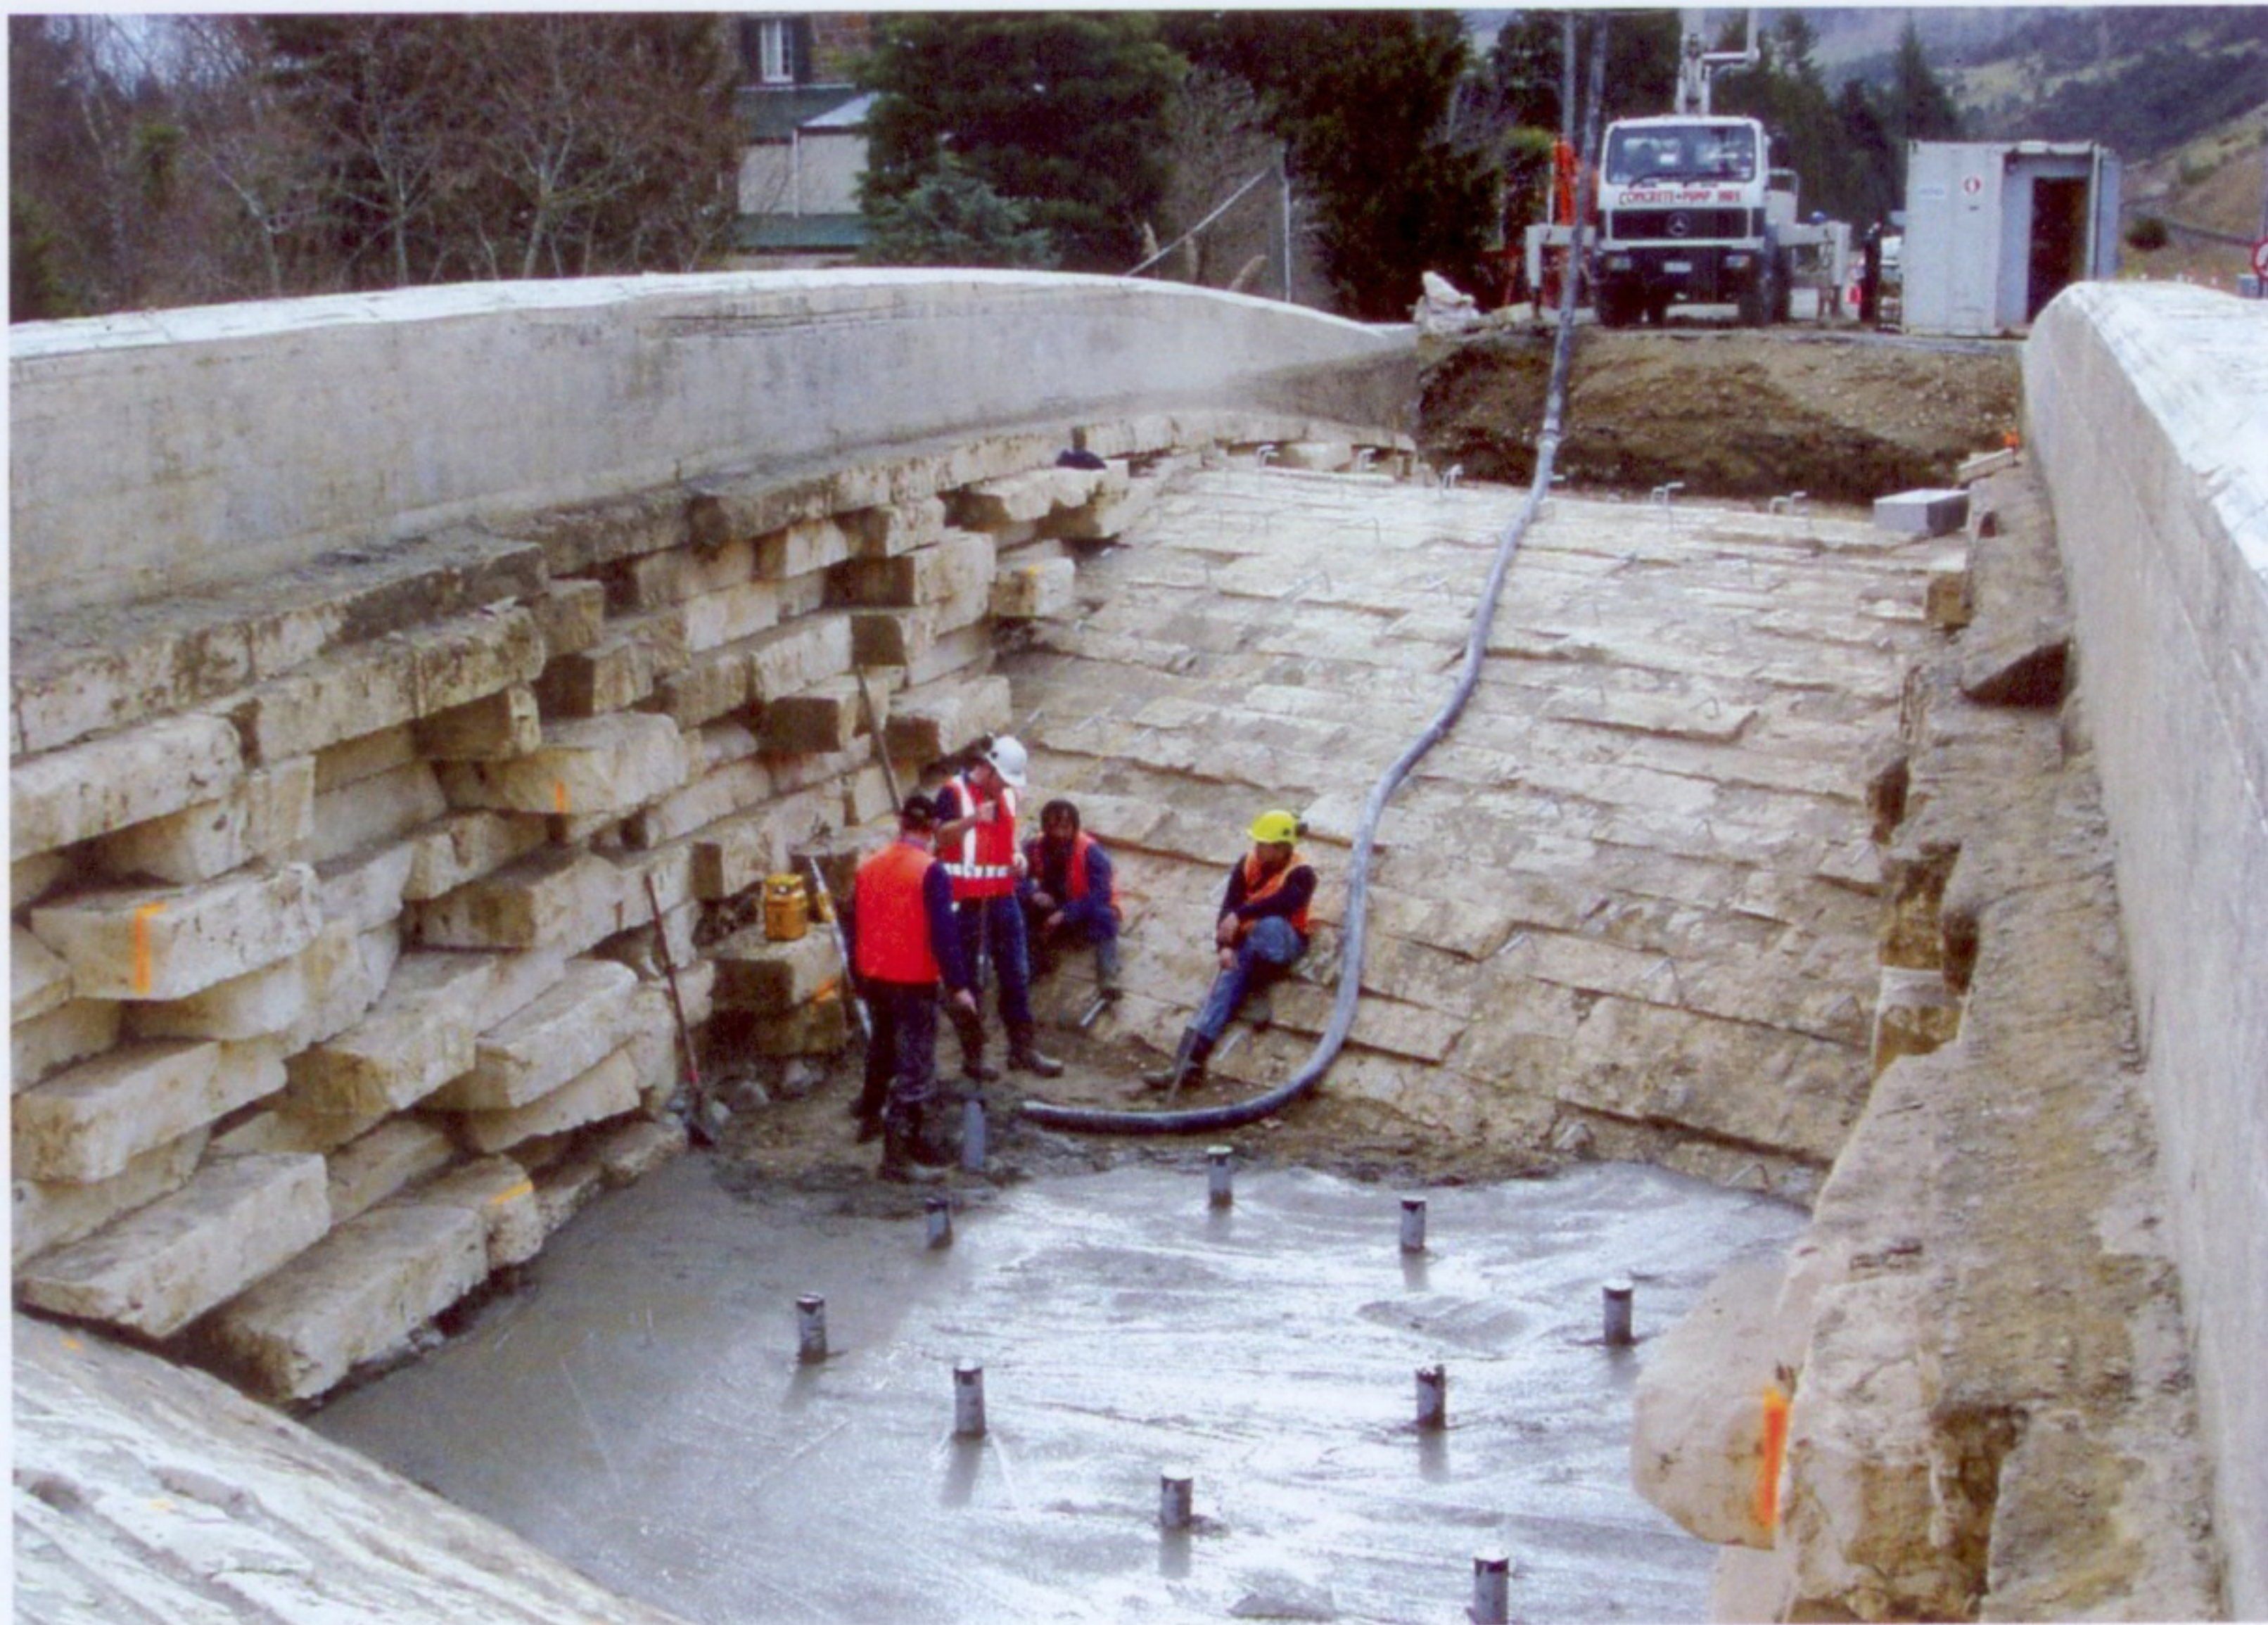
Upon excavation of the fill, the Opus designers were faced with the surprise discovery of extraordinarily long blocks of Oamaru stone in the spandrel walls. (Ref. Figure 2) This meant that the initial design had to be abandoned because the sleeper wall support point would have generated an intolerably long cantilever which in turn would have adversely affected the sight distance by impacting on the vertical alignment.

Figure 2. Exceptionally long slabs of Oamaru stone are seen protruding from the spandrel walls inside the excavated bridge.

Opus designers had to develop an alternative design that would address the existing constraints i.e. time, budget, historic protection, aesthetics, structural issues and construction practicalities.

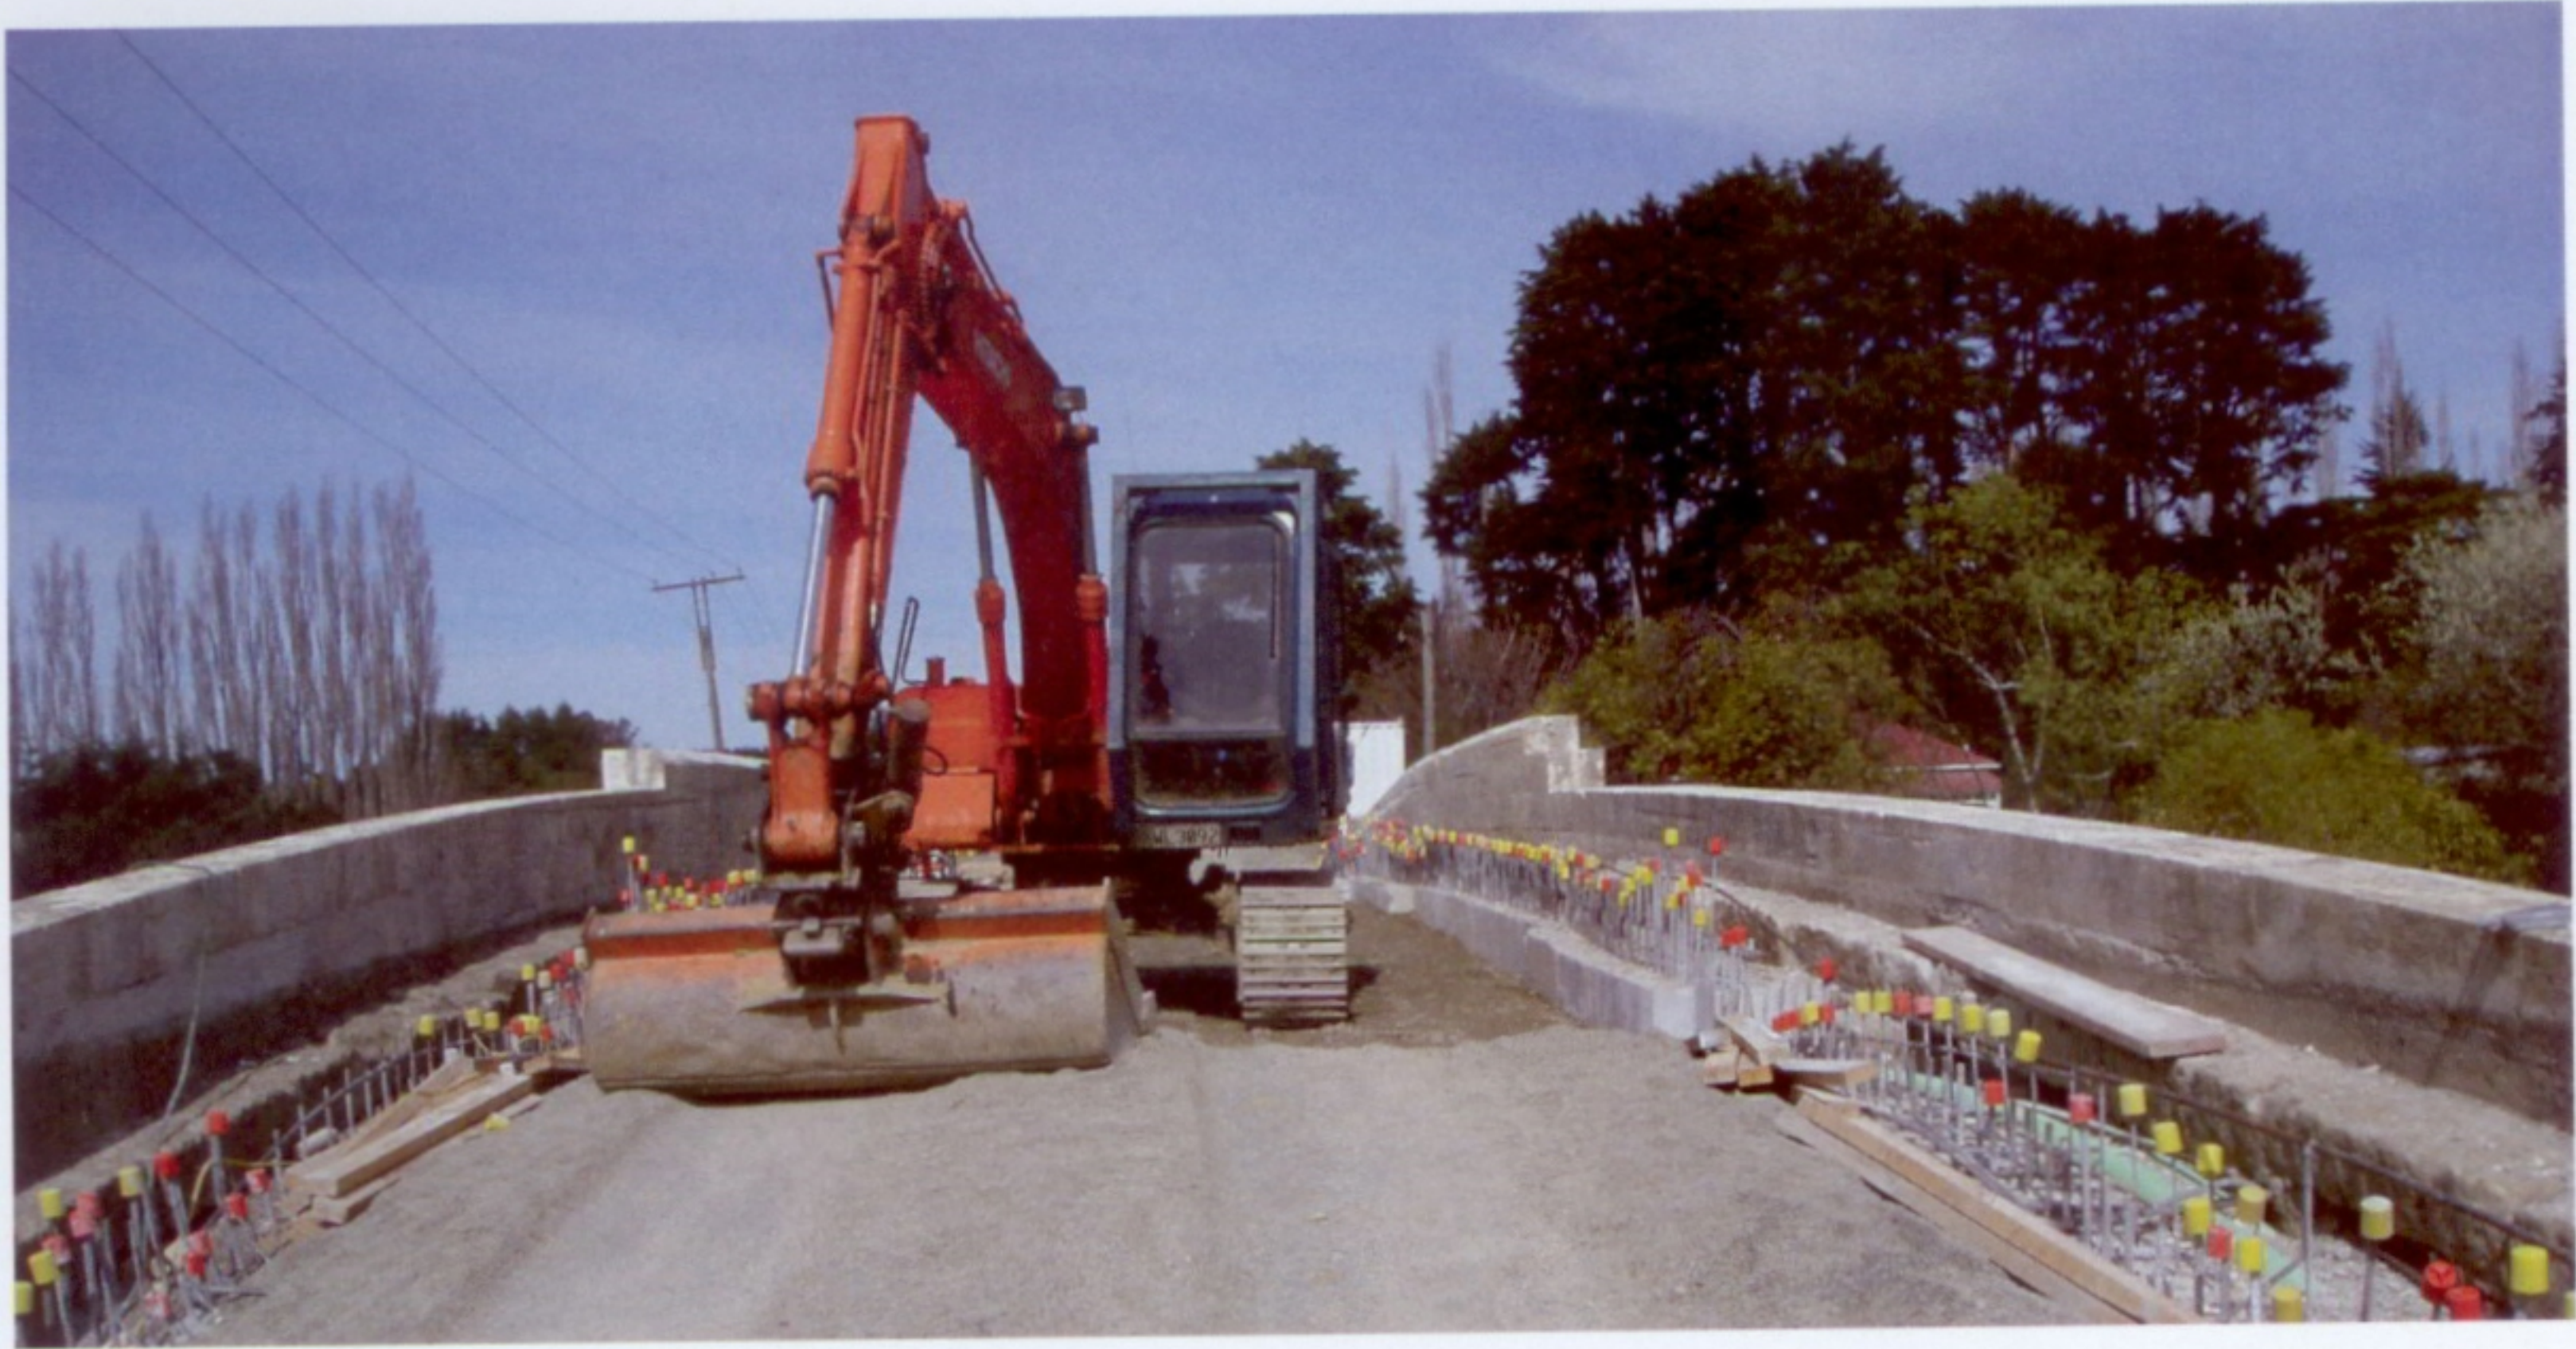
Figure 3. The bridge structure with the engineered fill in place. The parapet walls are in the process of being dismantled.

Correcting the significant vertical curve was a key safety outcome. Achieving this without changing the appearance of the bridge was only possible by constructing a deck at the level of the historic roadway and filling at the approaches. (Ref. Figure 3)

- a fully specified engineered fill (good quality infill topped with AP40:M4) for predictable high performance under load and minimal settlement
- careful compaction above the arch barrel
- meticulously specified compaction methodology

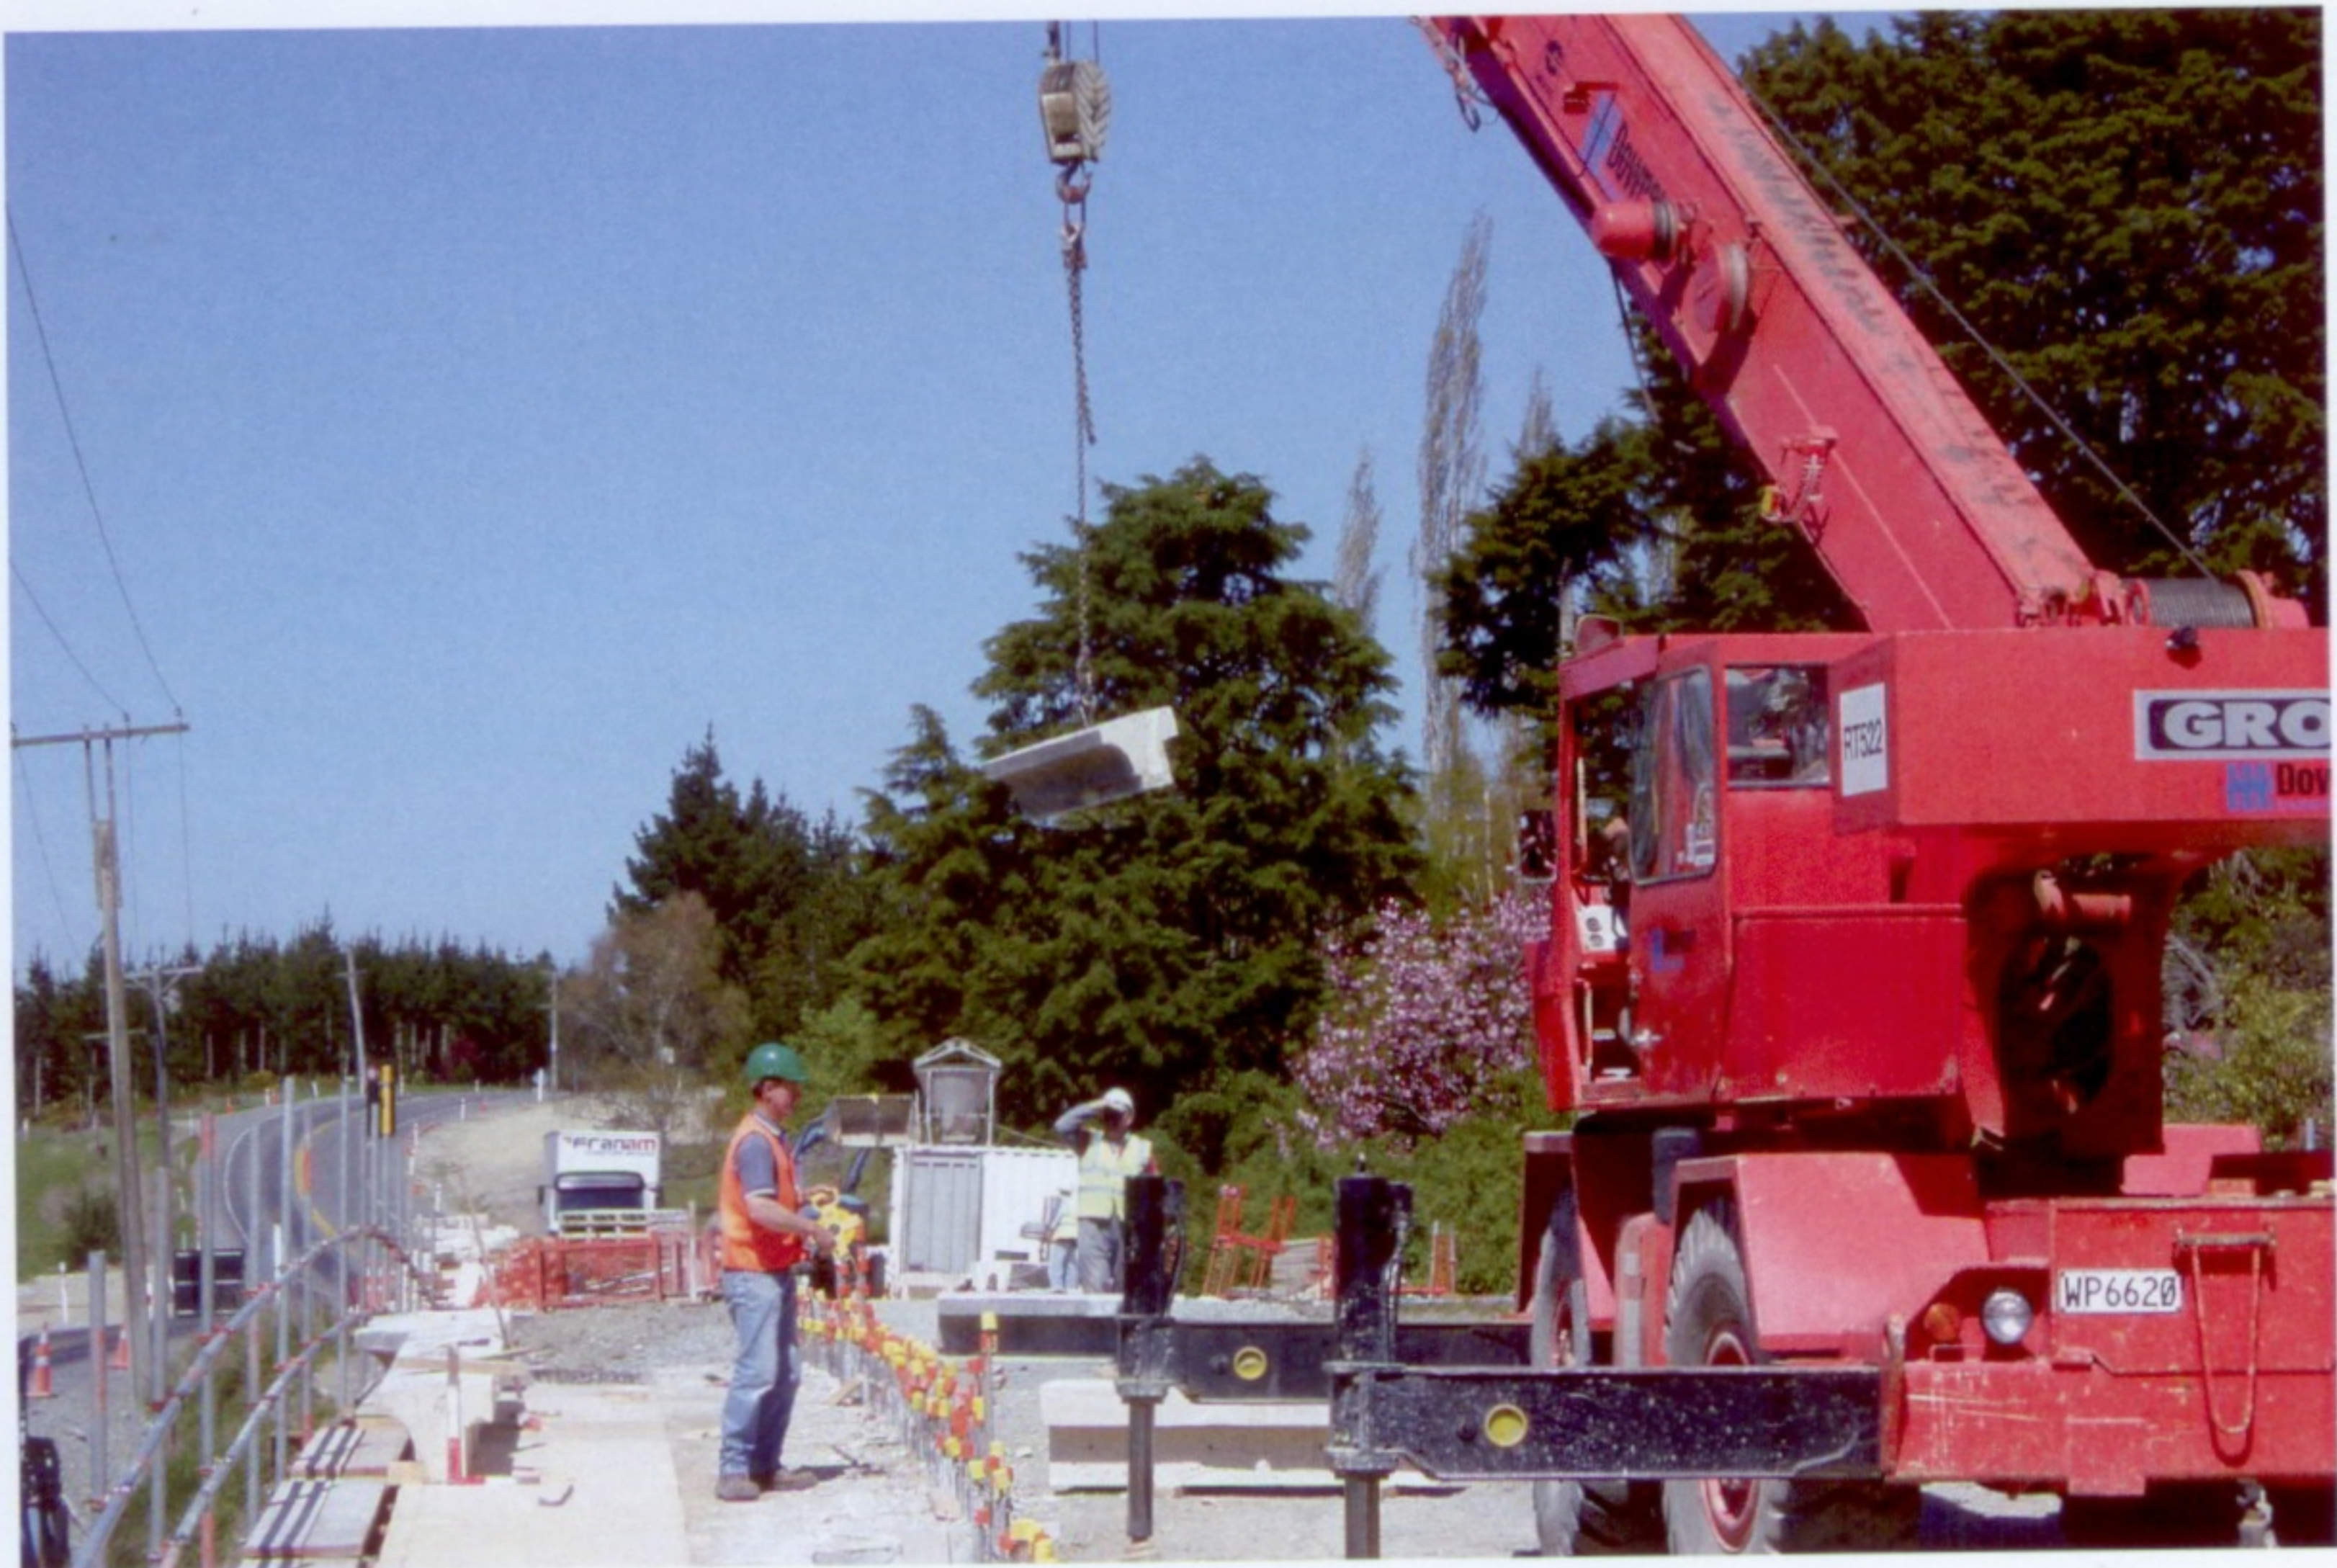
Figure 4. The decorative string course blocks are being repositioned on the cantilever formwork after being cut down to serve as permanent formwork for the deck.

The location of the deck and associated cantilever was defined by the vertical curve of the parapet and string course at deck level. (Ref. Figure 4)

Requirements for visual continuity over the vertical alignment, however, clashed with structural requirements for the thickness of the concrete deck.

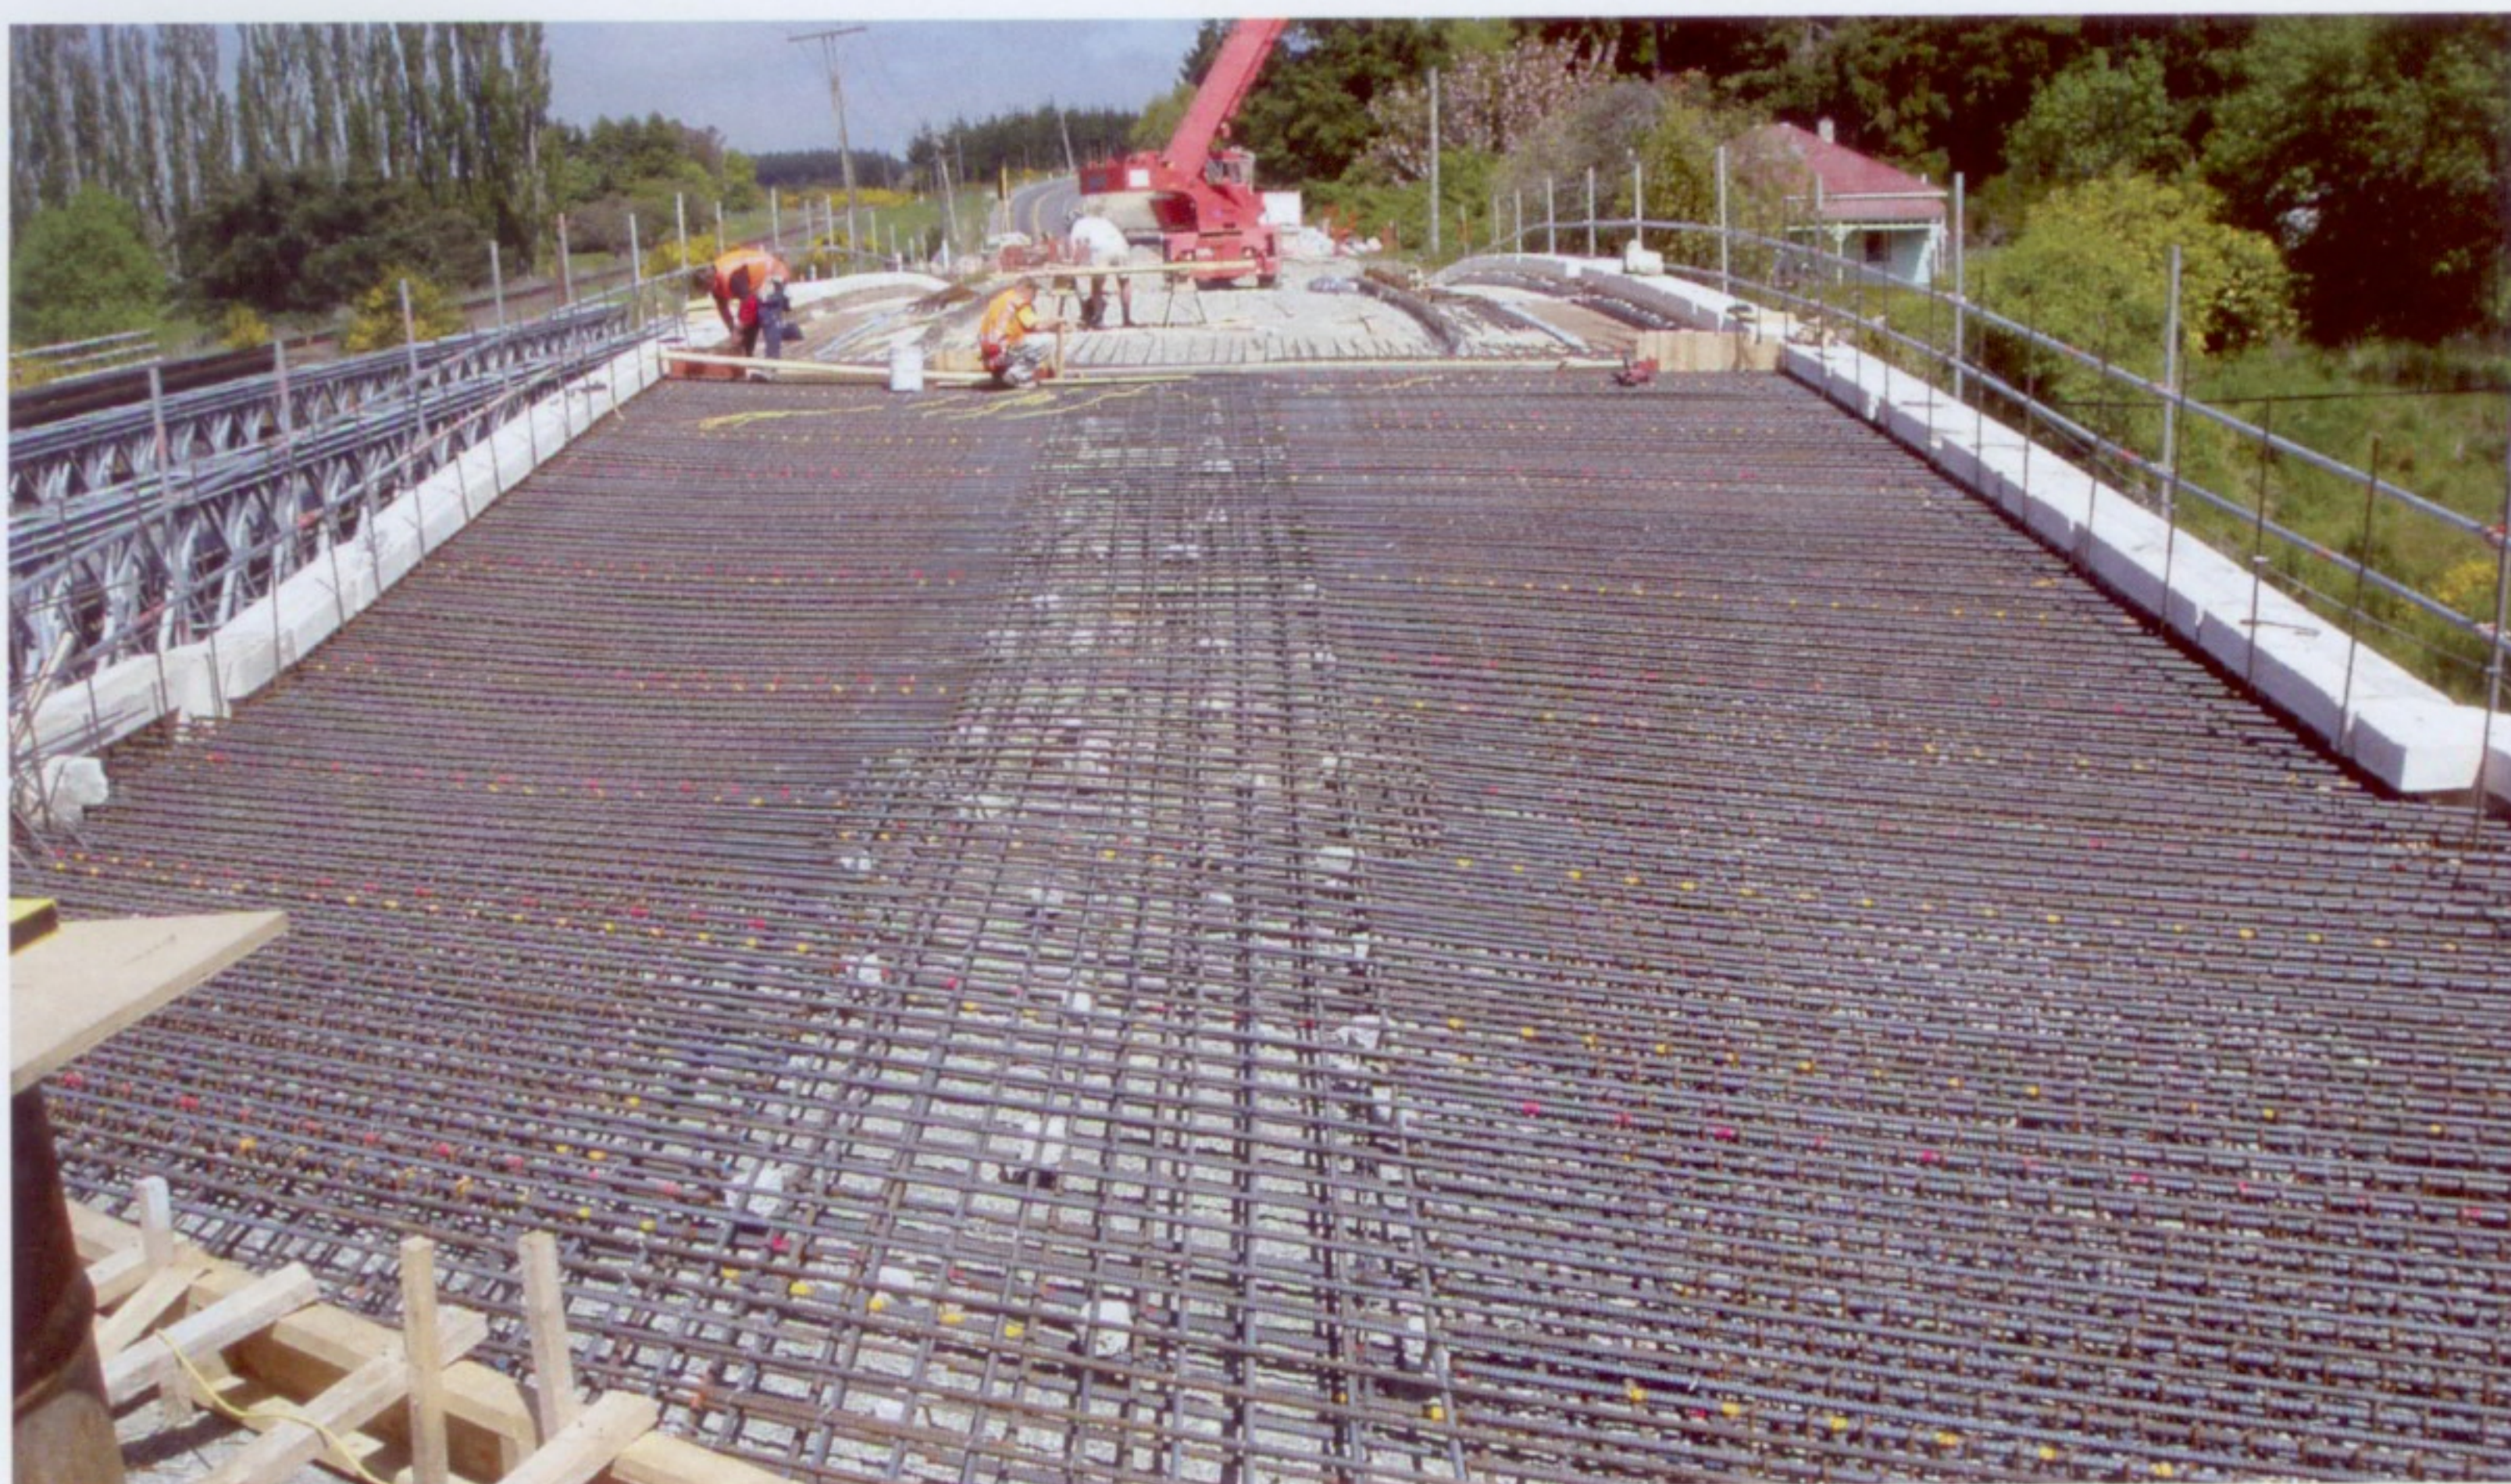
Figure 5. Using a thinner slab depth than ideal required more longitudinal reinforcement than an optimally proportioned slab and also shear stirrups.

Opus designers solved this structural dilemma by using a thinner slab depth with more longitudinal reinforcement and shear stirrups. (Ref. Figure 5)

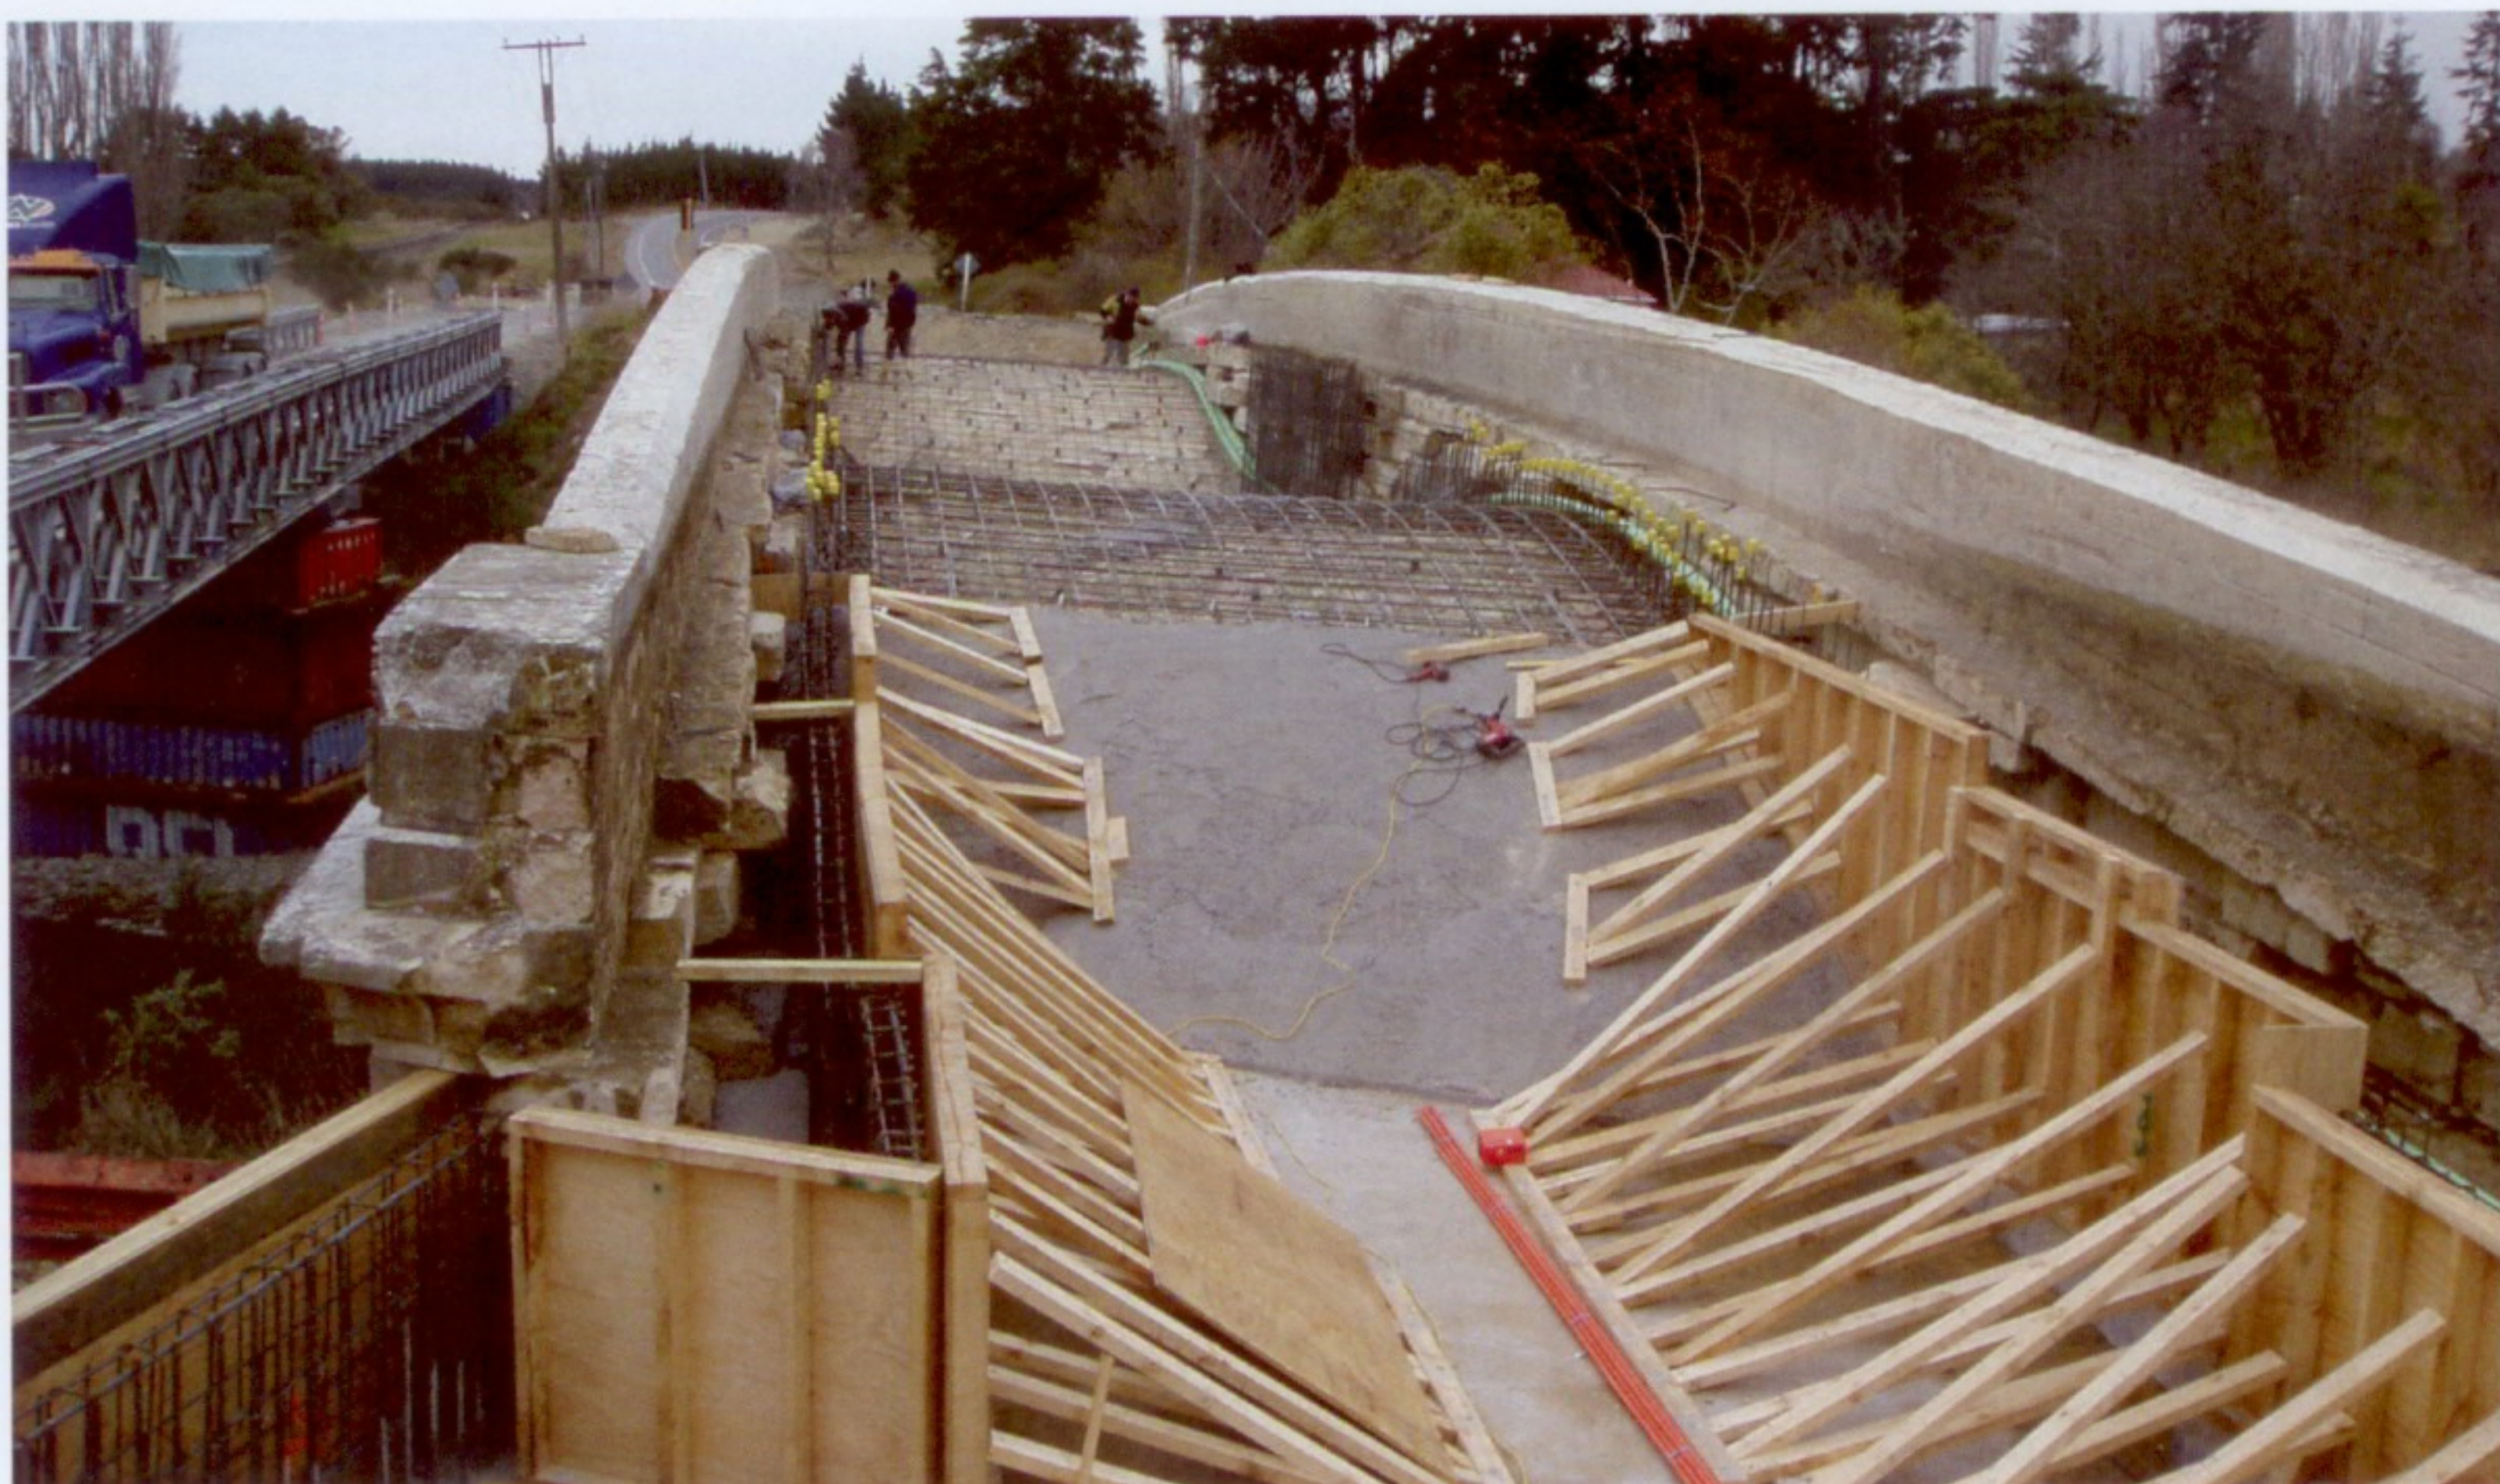
The longitudinal cracks – a result of lateral earth pressures – were effectively repaired with a reinforced concrete solution:

Figure 6. The saddle slabs under construction and formwork in place for the internal concrete spandrel walls.

- a reinforced concrete saddle was constructed over the exposed arch to absorb tensile forces
- the saddle was keyed into the arch barrel with reinforcing bars resin anchored into the arch (Ref. Fig 6 & 7)
- the spandrel walls were lined with reinforced concrete, keyed into the spandrel walls, thereby transferring any lateral forces to the saddle.
