Submission for the  
NEW ZEALAND CONCRETE SOCIETY  
**CONCRETE AWARDS 2007**

**WAIANAKARUA NORTH BRIDGE**

Submitted by: Dave Charters  
OPUS INTERNATIONAL CONSULTANTS

### **S.H.1 WAIANAKARUA NORTH BRIDGE WIDENING**

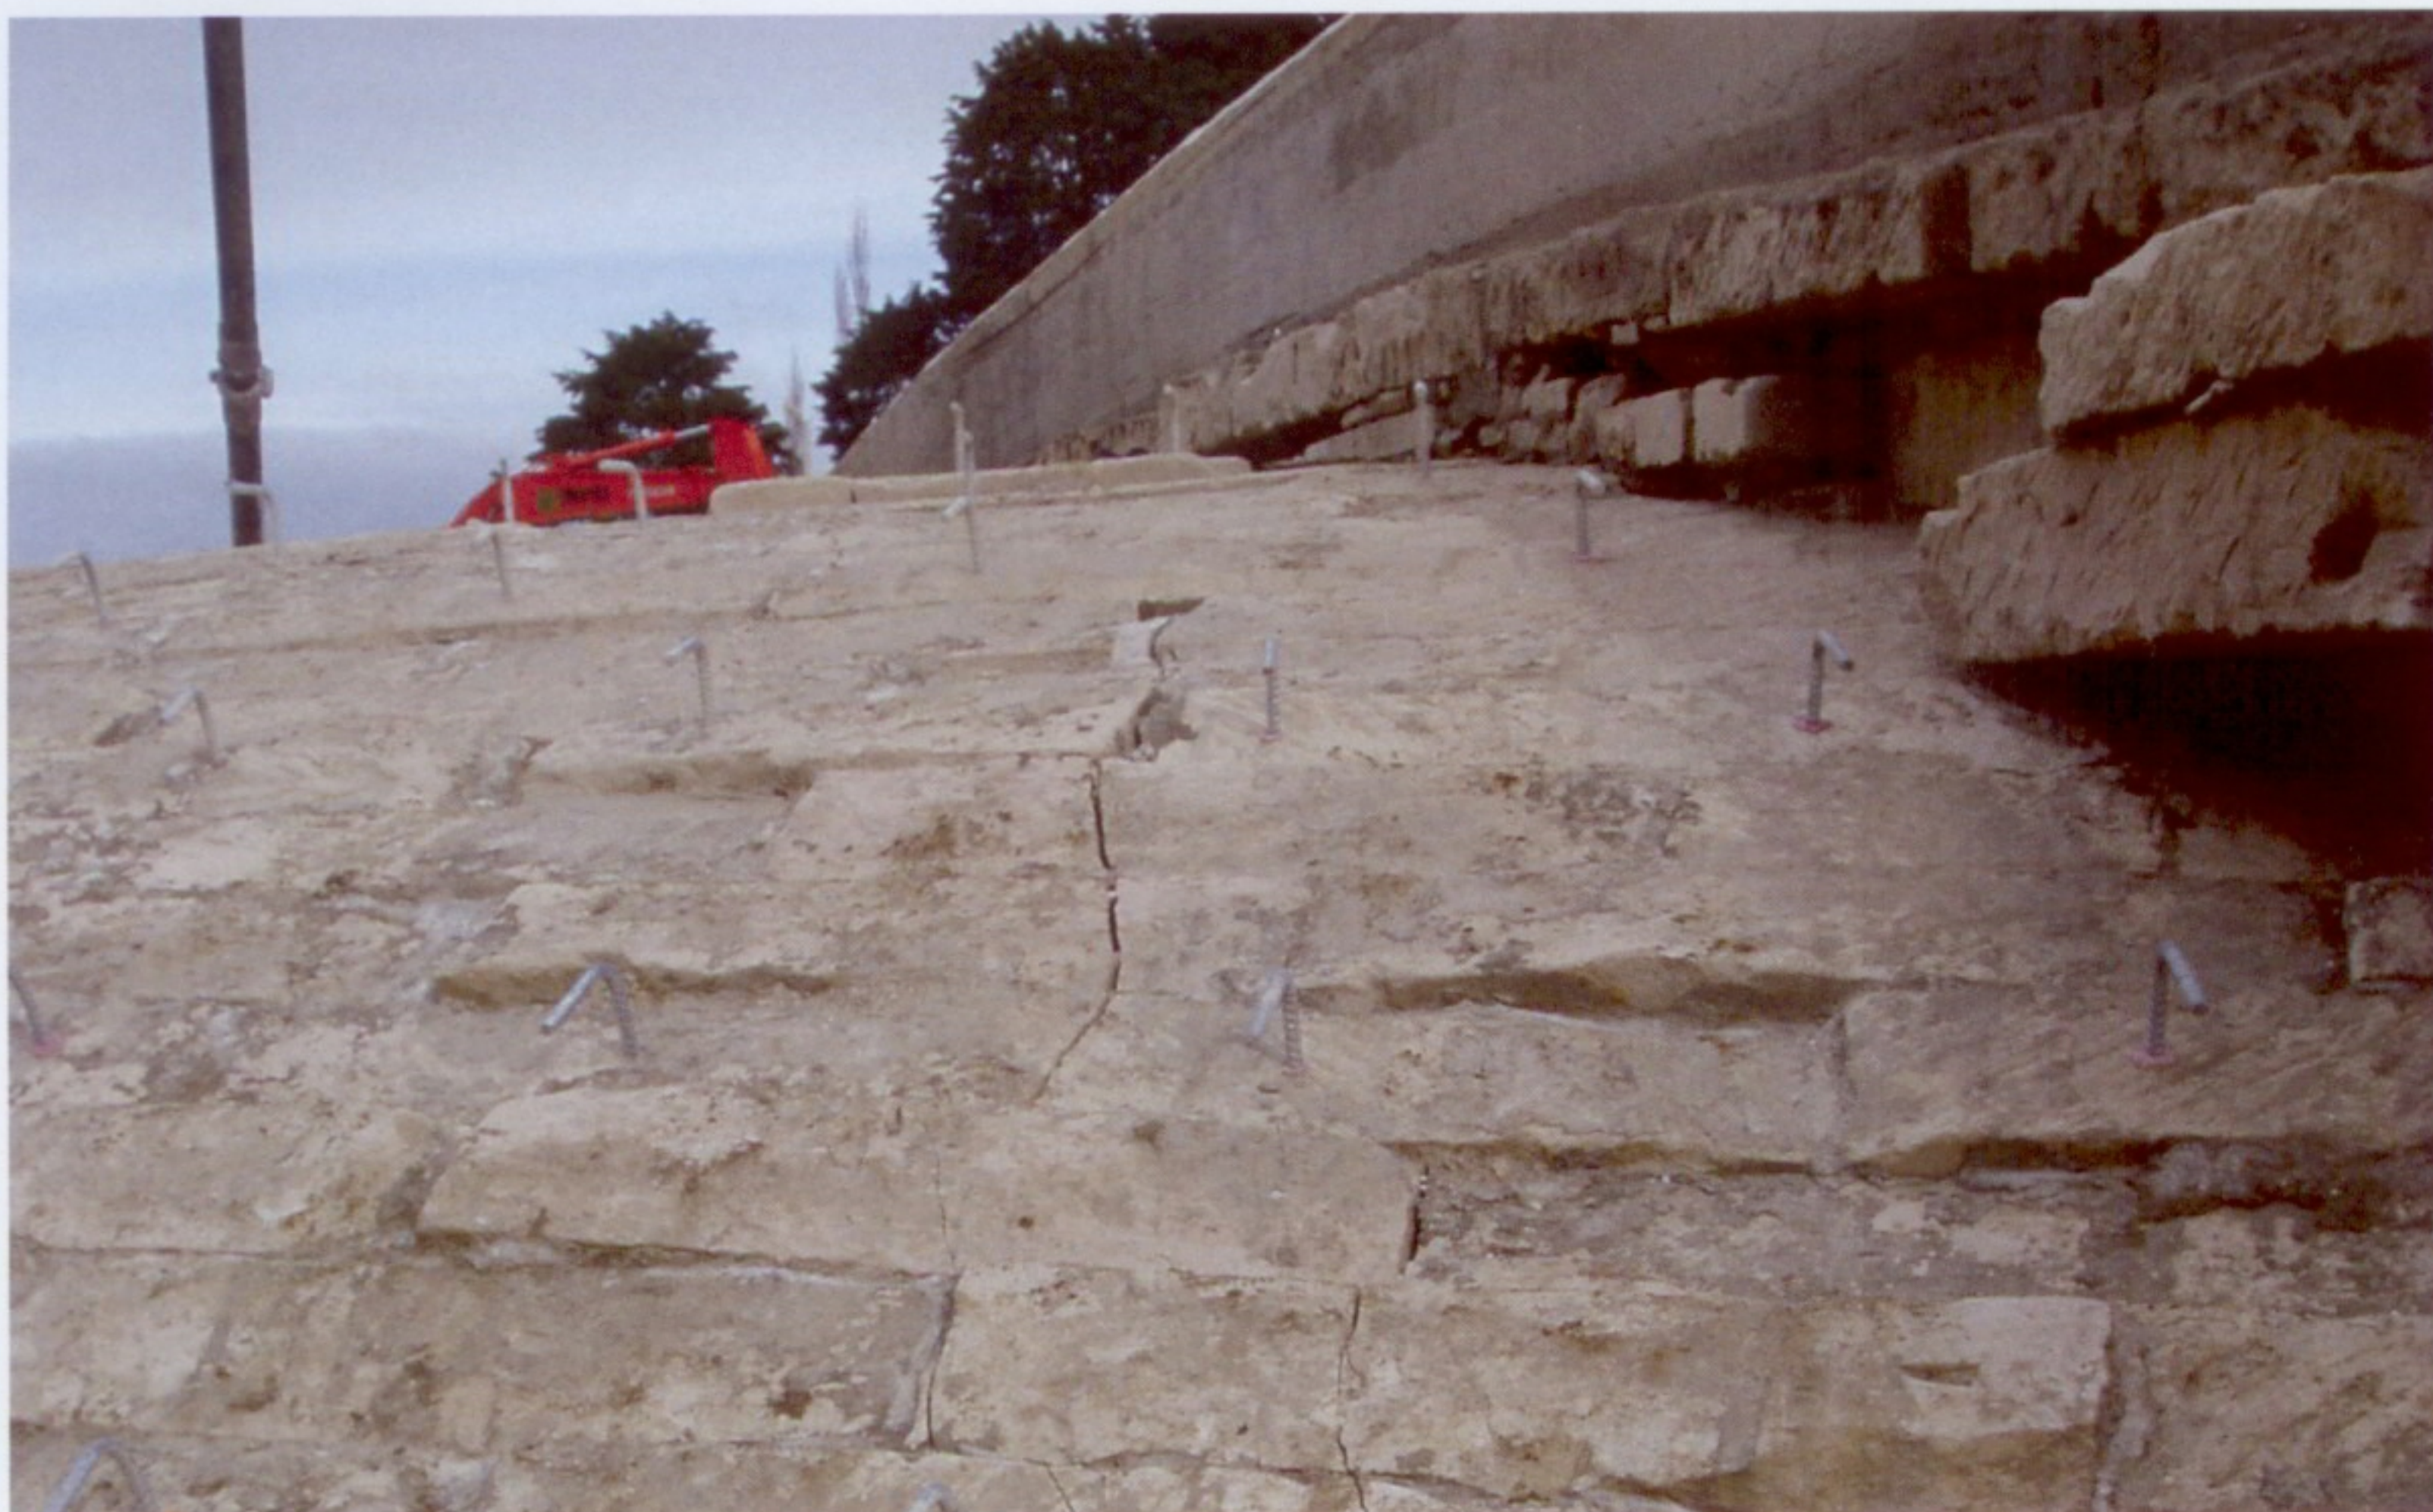
The Waianakarua North Bridge no longer met modern traffic requirements due to its poor horizontal alignment and narrow width. A pronounced 'hump' represented an increased traffic risk due to reduced sight distances. In addition, longitudinal cracking in the arch barrel was evidence of significant structural stress.

Figure 7. The exposed bridge barrel following excavation of the fill.

- a reinforced concrete saddle was constructed over the exposed arch to absorb tensile forces
- the saddle was keyed into the arch barrel with reinforcing bars resin anchored into the arch (Ref. Fig 6 & 7)
- the spandrel walls were lined with reinforced concrete, keyed into the spandrel walls, thereby transferring any lateral forces to the saddle.

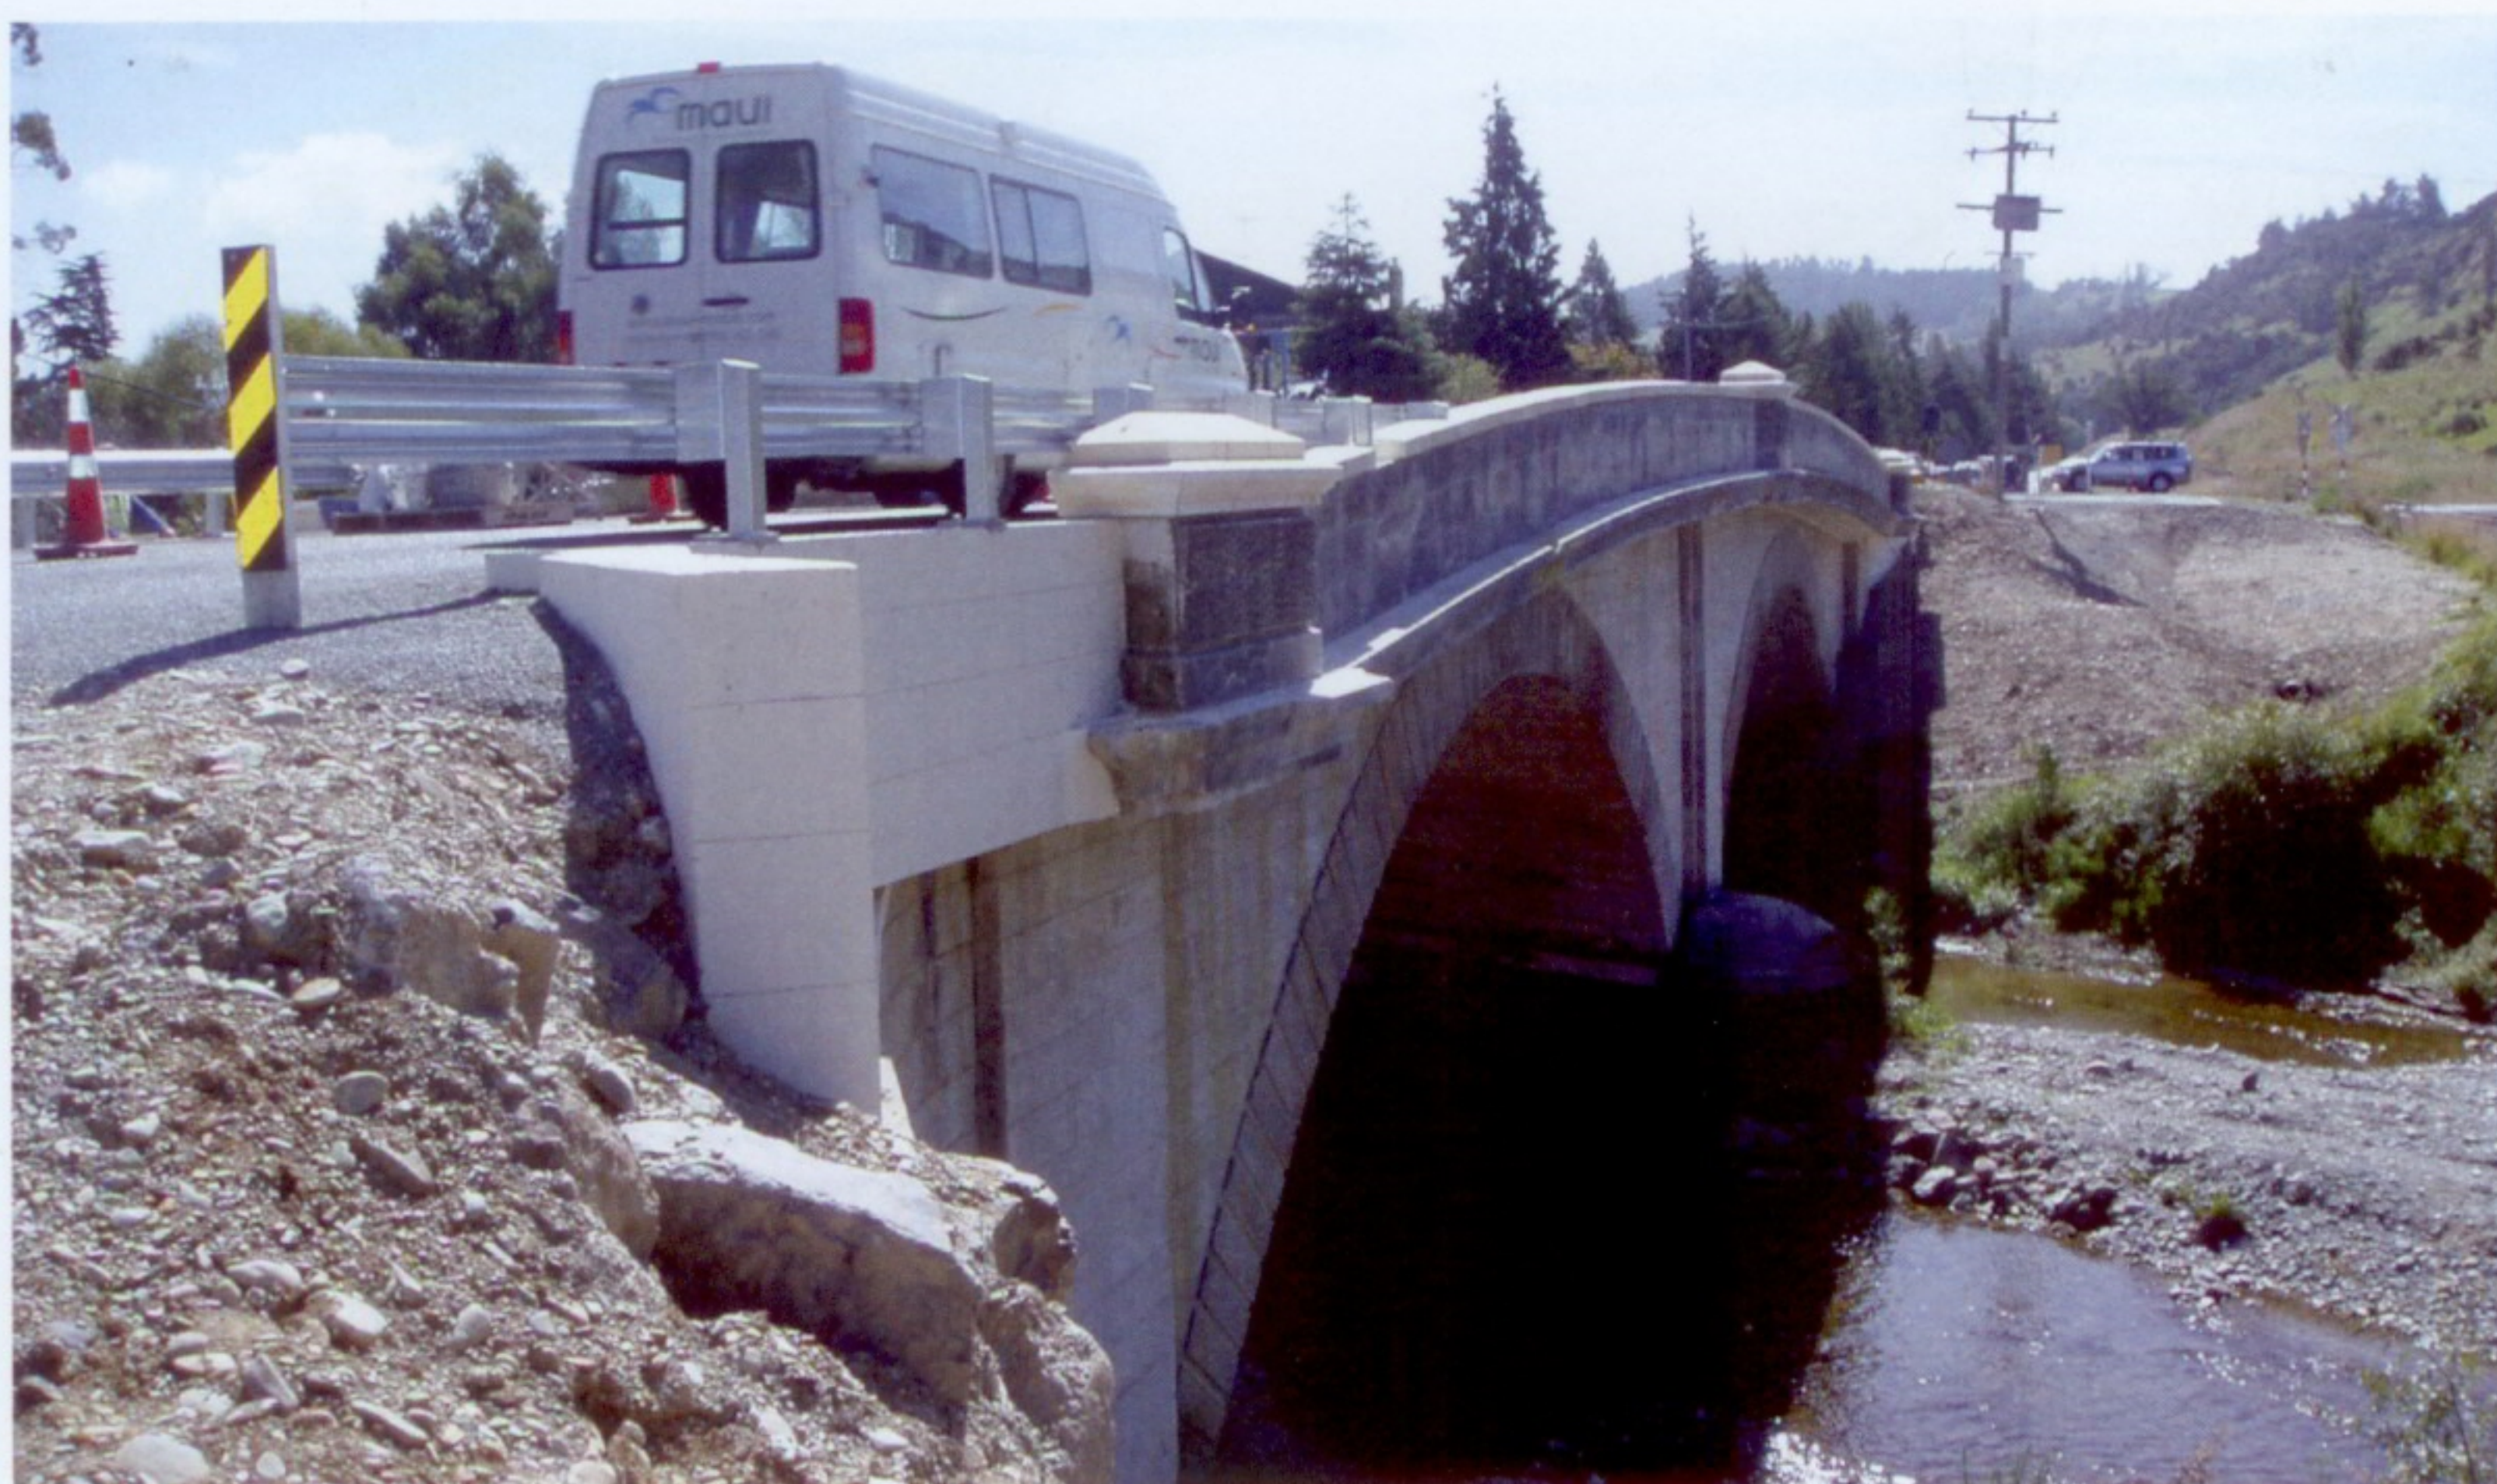
Figure 8. The completed widened bridge with strengthened parapet walls and new capping stones to replicate the originals which were removed during the 1960s.

The stone parapet was reinforced and stressed before it was rebuilt with a high degree of historic authenticity and the same level of craftsmanship as the original bridge structure. The top course of the parapet wall is a concrete bond beam faced with stone cut from the original top course of the parapet wall. (Ref. Fig 8)
